Manhole Inspection Summary

Manhole # S25KK_032MH

Location Address: **2328 MCCULLOH ST** Cross Street: **CLENDENIN ST**

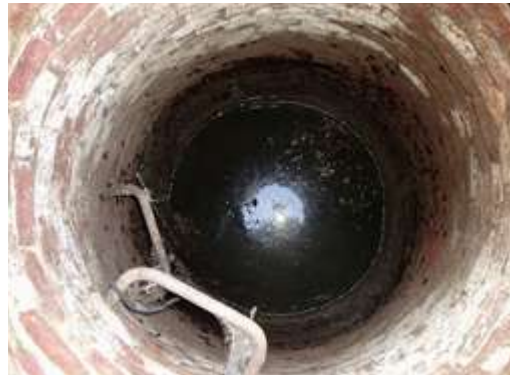
Top View

Active surcharge - 1st visit.

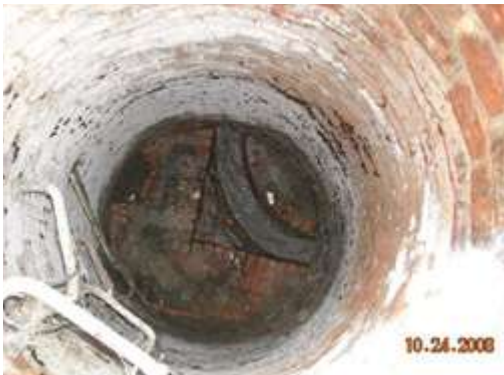
Top View

Corroded steps. Evidence of surcharge - Bench debris.

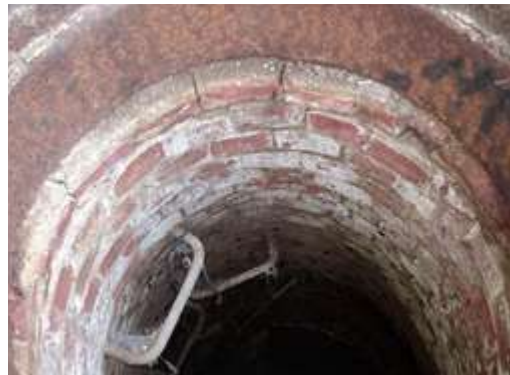
Defect

Adjustment deterioration and infiltration. Corbel and Barrel infiltration.

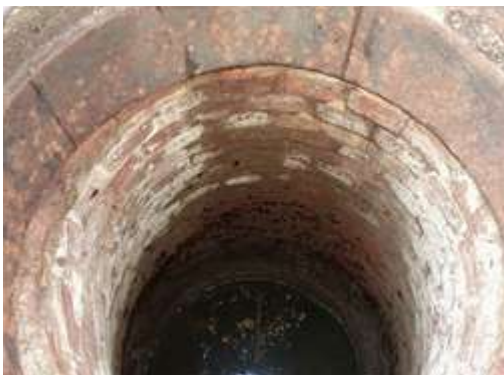
Defect

Adjustment, Corbel and Barrel infiltration.

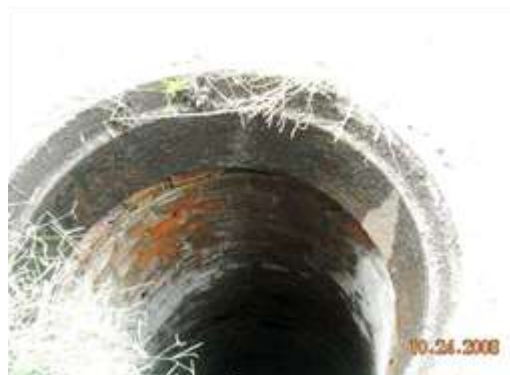
Defect

Frame leaks. Adjustment deterioration and infiltration. Corbel and Barrel infiltration.

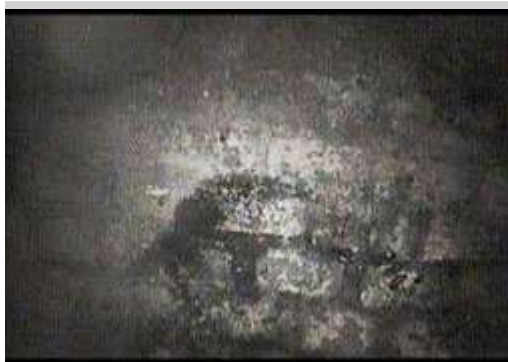
Defect

Barrel infiltration.

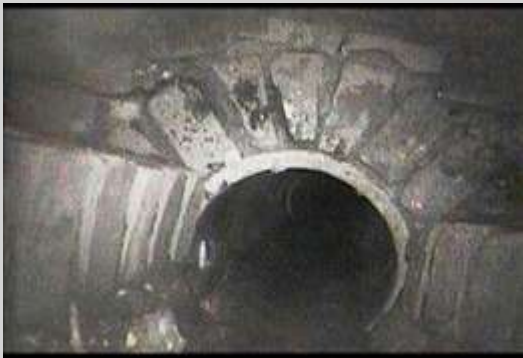
8 in. Circular Gravity Sewer Pipe Out @ 12 O'Clock

Pipe Material: **Clay** ☐ Pipe Lined

Invert Depth: **10.78** (ft.) Flow Characteristics: **Fast**

Deposits: ☒ None ☐ Mud ☐ Sludge ☐ Debris ☐ Grease

Infiltration: **None** Pipe Seal Cond: **Unknown**

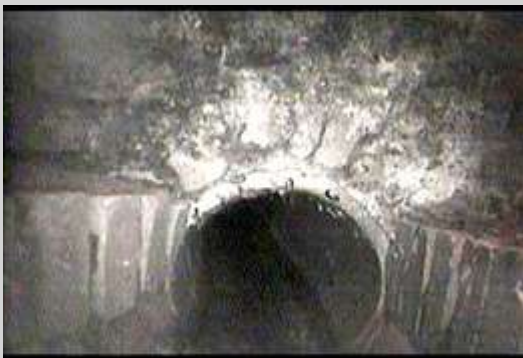
8 in. Circular Gravity Sewer Pipe In @ 3 O'Clock

Pipe Material: **Clay** ☐ Pipe Lined

Invert Depth: **10.70** (ft.) Flow Characteristics: **Fast**

Deposits: ☒ None ☐ Mud ☐ Sludge ☐ Debris ☐ Grease

Infiltration: **None** Pipe Seal Cond: **Unknown**
